Building Inspection Report

W1234 John Hills, My Town, WI 56789

Inspection Date:
01/28/13

Report Number:
2013-0128 Hills

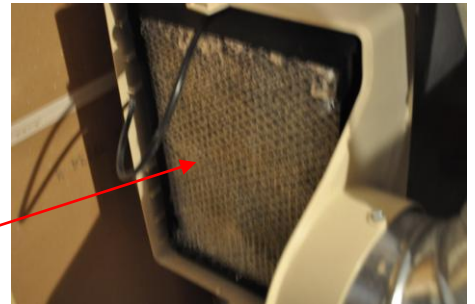
- **Repair:** The humidifier has lacked maintenance. Cleaning and repairs should be undertaken. Watch out for humidifier leaks into the furnace where costly (and hidden) damage can occur.
- **Repair:** The dirty air filter should be replaced. The furnace, heat recovery unit, and the April -air unit all have filters to maintain.

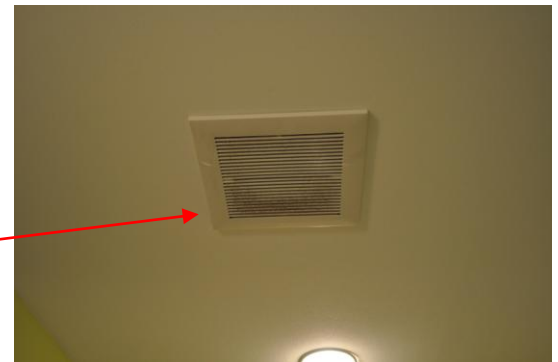
- **Repair:** The second floor bath fan needs to be cleaned. Keeping the fan grill clean and free from debris will help remove the moisture in the room.

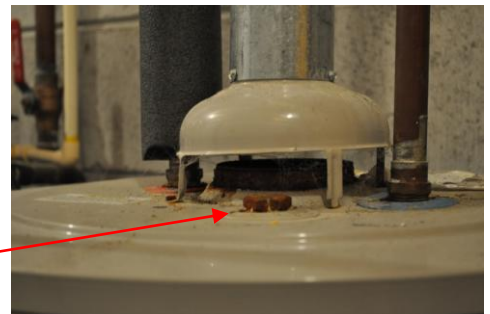
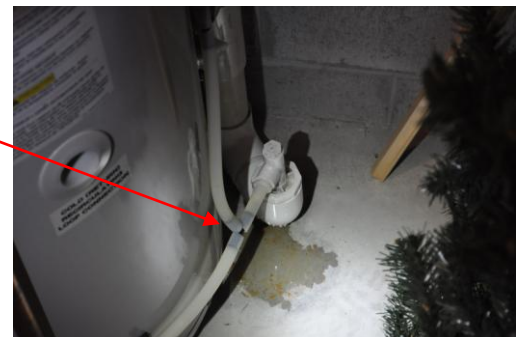
- **Safety Issue:** The water heater venting system shows evidence of exhaust "spillage". *This is a serious condition that could be a health threat to the occupants of the home.* This condition should be addressed promptly. The venting system is complex and it has many long runs and angles to vent out the roof. Recommend having a licensed plumber inspect the water heater.
- **Repair:** A connection to the newer water heater is leaking.

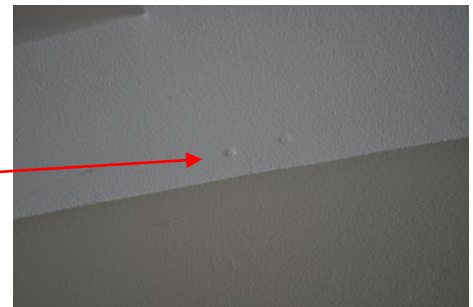
- **Monitor:** Minor cracks were noted.
- **Monitor:** Typical drywall flaws were observed. Nail pops and small shrinkage cracks are very common in newly constructed homes.

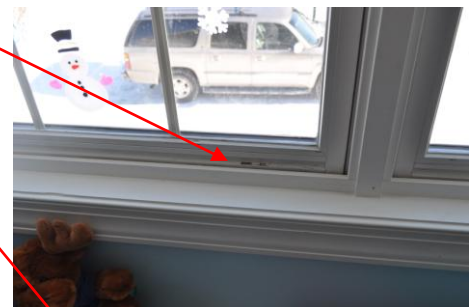
- **Monitor:** The windows show evidence of condensation. This is not a Major Concern. Controlling indoor humidity levels and/or improving window efficiency (if needed) would help to control this condition. This is only a concern if the windows are left as it. They need to be scraped and repainted before wood rot begins.
- **Repair:** The glazing seal of a window in the master bedroom is loose. Have this repaired by a professional.

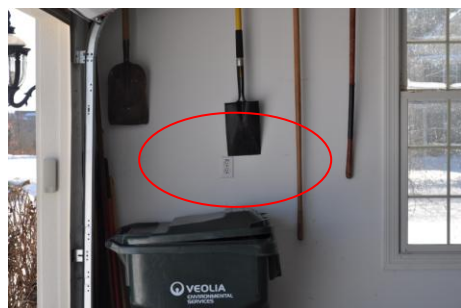
Two outlets in the garage trip the GFCI when I plugged my tester in. Recommend an electrician investigate.

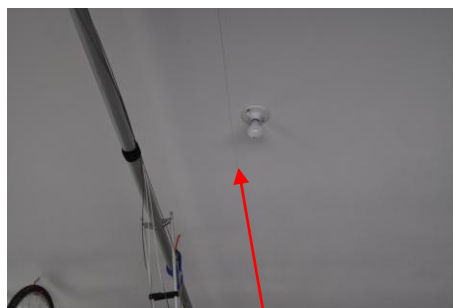
Shrinkage cracks located on the garage ceiling. Common with new construction.

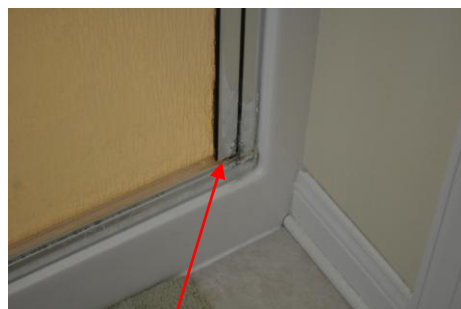
A little corrosion found on the bottom of the master bath shower door.

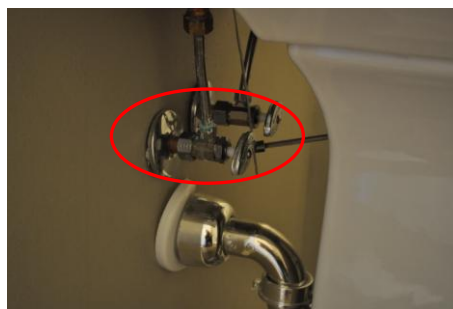
Corrosion build-up on the supply line in the lower bath. Recommend turning the valves once a year to prevent them from sticking.

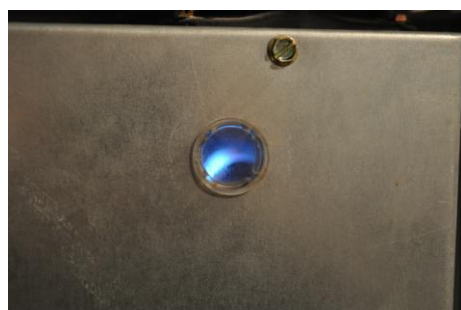
The flame in the furnace is nice and blue. This means the furnace is burning clean and efficiently.

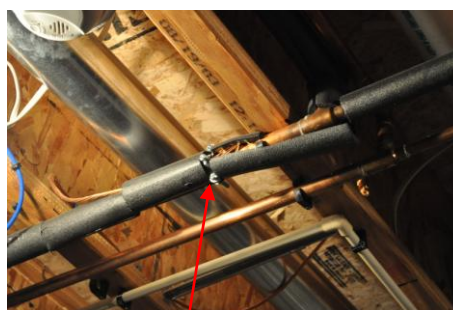
The electrical system is grounded to the plumbing. This is a good source of grounding.

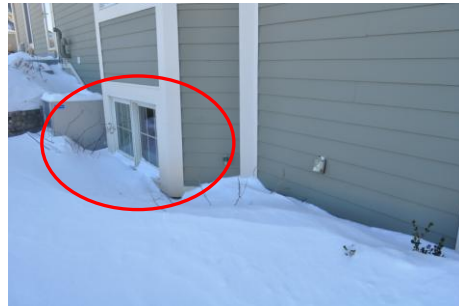
Remove the snow from the window sill. This will stop the acceleration of wood rot.

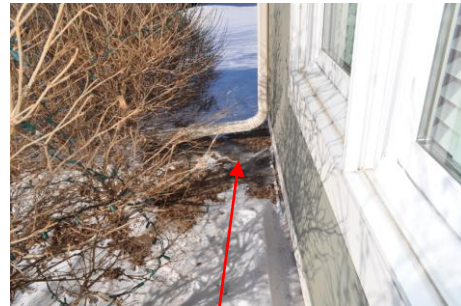
A low spot was observed on the SW corner of the house. Fill with black dirt so that you maintain positive grade.

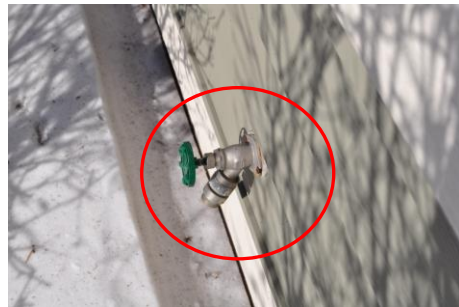
The outside hose bibs are shut off inside and they all have anti-siphon devices. Very good!

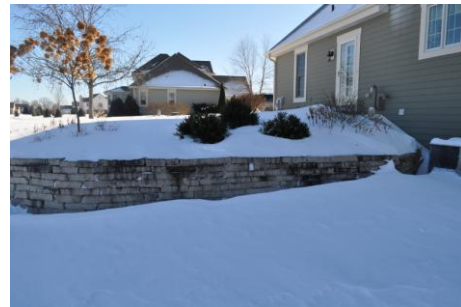
The retaining wall is in good shape. The moss and mildew gives it character.

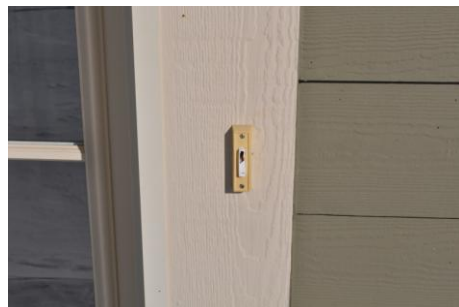
Door bell button is cracked. This is an inexpensive fix.
