Building Inspection Report

W1234 John Hills, My Town, WI 56789

Inspection Date:
01/28/13

Report Number:
2013-0128 Hills

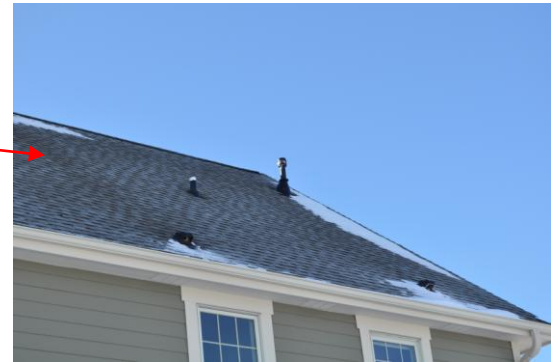
The roof coverings are newer and appear to be in generally good condition. The steep pitch of the roof should result in a longer than normal life expectancy for roof coverings.

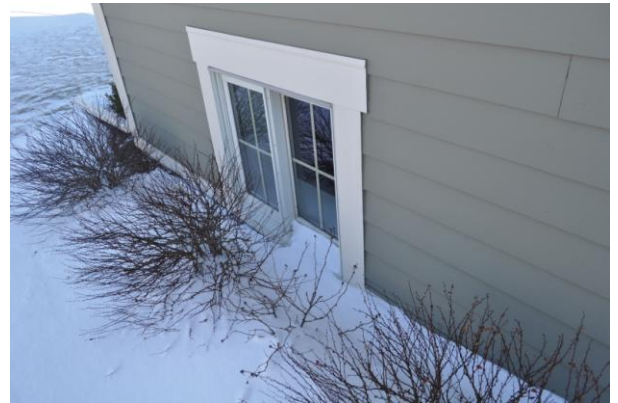
The exterior of the home is generally in good condition.

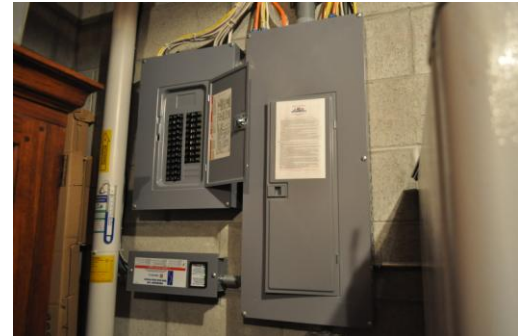
The size of the electrical service is sufficient for typical single family needs. Generally speaking, the electrical system is in good order. All outlets and light fixtures that were tested operated satisfactorily. The distribution of electricity within the home is good. All 3-prong outlets that were tested were appropriately grounded. Ground fault circuit interrupter (GFCI) devices have been provided in some areas of the home. These devices are extremely valuable, as they offer an extra level of shock protection. All GFCI's that were tested responded properly. Dedicated 220 volt circuits have been provided for all 220 volt appliances within the home. All visible wiring within the home is copper. This is a good quality electrical conductor.

Inspection of the electrical system did not reveal the need for improvement.

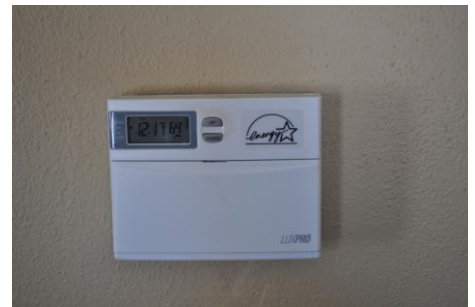
The heating system shows no visible evidence of major defects. No repairs to the heating system are necessary at this time.
